What You Need to Know About Propeller Shafts and Couplings

- Craig Johnston, S/V Sequoia

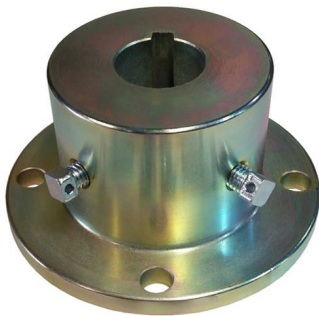
Figure 1. Solid transmission shaft coupling. Note the keyway and the two locking screws which should bear on depressions in the shaft and be seized with wire.

1. The transmission coupling, a flanged assembly that bolts onto the output of the transmission and clamps onto the driveshaft. (see Figures 1,2 and 3)

The shaft at the engine coupling may be either straight or tapered but usually has a key, a square metal bar that rests in slots (called keyways) half in the shaft and half in the transmission coupling. This locks the shaft to the engine rotationally. The coupling may be solid or split into two halves, with bolts to clamp it onto the shaft. Additionally, there is a bolt that bears on a hole or dimple in the shaft to keep it from pulling out. If the shaft is tapered to fit into a matching taper in the coupling, there will typically be a bolt through the center of the coupling into the end of the shaft that prevents the shaft from pulling out.

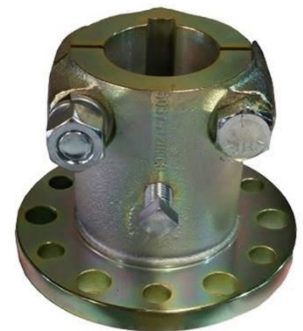
Figure 2. Split transmission coupling. Ideally, both pinch bolt nuts and the setscrew should be drilled for seizing wire.

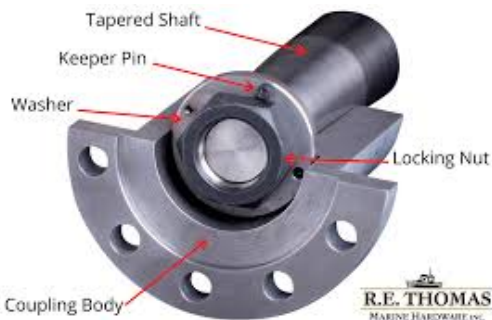
Figure 3: Cutaway view of a tapered shaft coupling. The locking nut and washer provide positive retention when backing down pulls on the shaft.

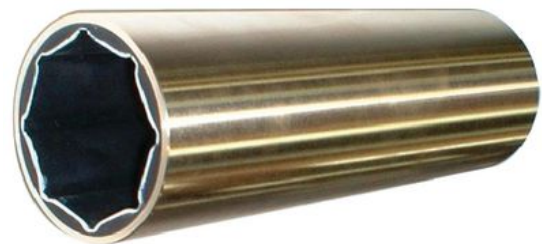
Figure 4. Cutless bearing. This is pressed into a strut or the back of the keel and held in place with setscrews.

2. The driveshaft, which transmits the power from the engine to the prop.
3. The shaft log which seals around the driveshaft where it penetrates the hull.
4. A cutless bearing (Fig.4), which constrains the driveshaft just forward of the prop and is contained either in a strut or the trailing edge of a full keel. It operates underwater using rubber fingers as bearing surfaces.

The cutless bearing uses the unusual properties of rubber as a low friction bearing surface when flooded with water. Cutless bearings are remarkably durable but need periodic replacement when worn.

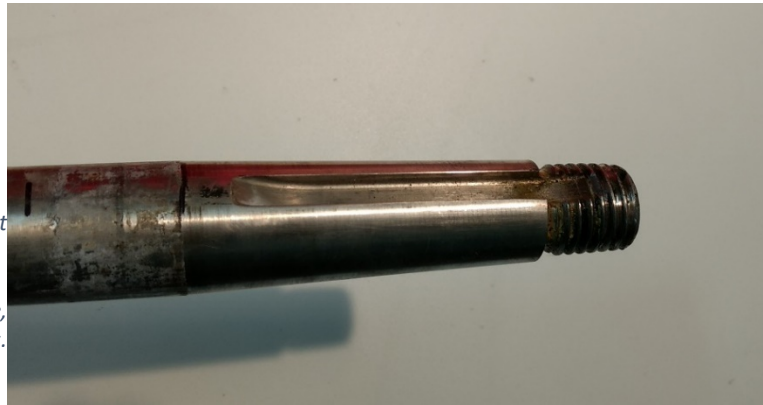
Figure 5. Prop end of shaft. Note that the threaded end is smaller diameter than the body of the shaft. These threads are right-handed, but beware, some shafts have left-handed threads.

5. The propeller, which is fixed to the end of the driveshaft. (see Figure 5, prop end of shaft).

The propeller is fit onto a taper at the end of the shaft, with a key and one or two nuts to hold the prop on when reversing. A correctly fitted prop will jam onto the taper so tightly that a puller is necessary to

remove it. Because of the taper, the threaded part on the end is smaller diameter than the shaft. For a US standard shaft of 1.5 in. diameter, the standard thread is 1 1/8 - 7.
